# Assessment of safety performance level on simple urban residential building: Case study at Bogor city Indonesia

M Lutfi<sup>1</sup>, H Arien<sup>2</sup>, M Hendrawati<sup>3</sup>, P J Ramadhansyah<sup>4</sup> and N I Ramli<sup>4</sup>

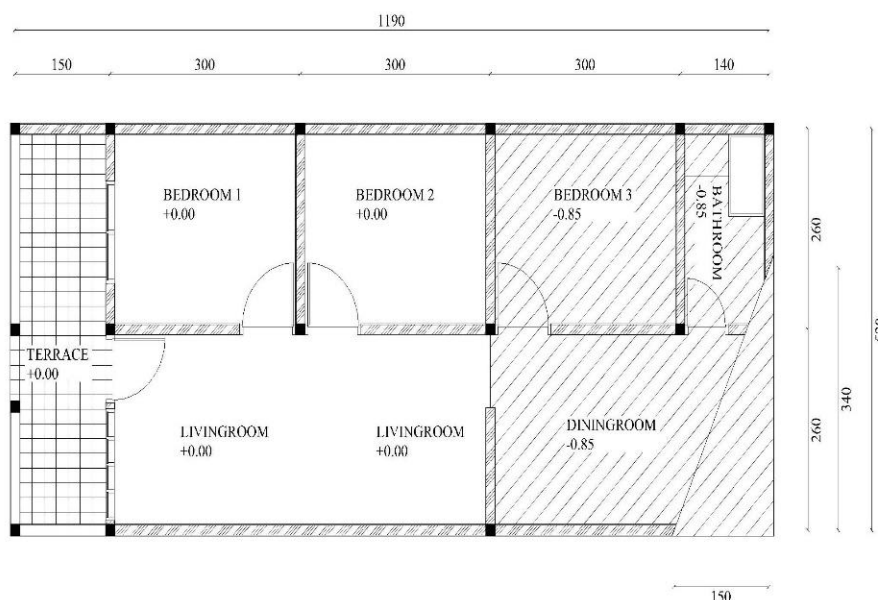
The specifications of the existing residential buildings are 520 cm X-direction and 1190 cm Y-direction, 300 cm height Z-direction using 15x15 cm column dimension, 15x18 cm dimension beam, 17 MPa concrete (FC), 4D12 BJTP main reinforcement, and shear reinforcement D8-20, is in quake zone 4 with the medium type of soil (Figure 1).

**Figure 1.** Existing residential building

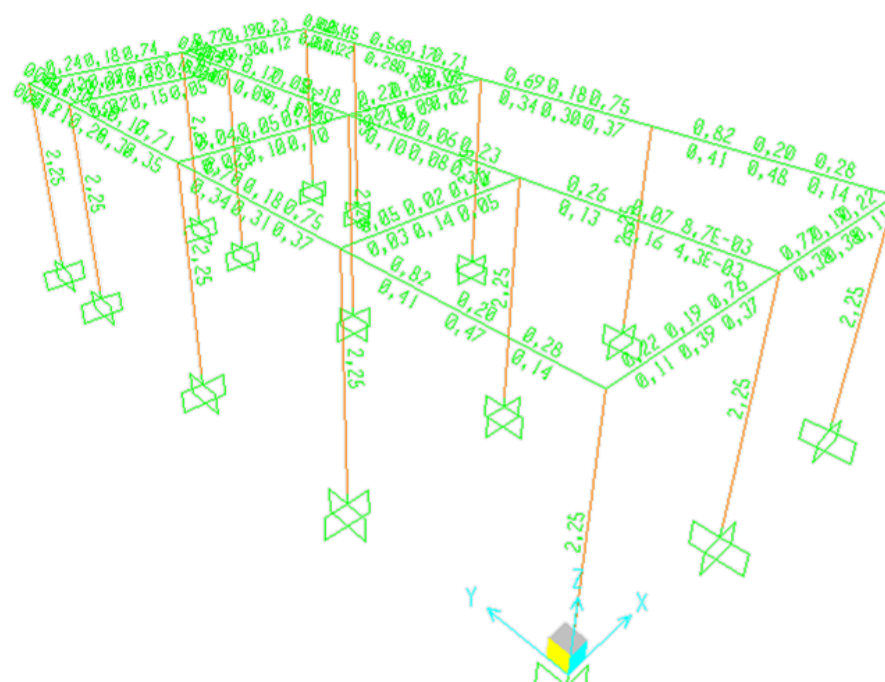
From the modeling, we performed a structural analysis with a load combination of dead load covering roof  $3 \text{ m} \times 10.4 \text{ m} \times 50 \text{ kg/m}^2 = 150 \text{ kg/m}^2$ , ampig wall  $(1.54 \text{ m} \times 250 \text{ kg/m}^2) / 2 = 192.5 \text{ kg/m}^2$ , hanging =  $11 \text{ kg/m}^2$ . Live load on roof =  $100 \text{ kg/m}^2$ . Earthquake loads using spectrum response data based on the Public Works Research and Development Center [10,11,12]. The results of the load combinations analysis obtained for the column structure elements are almost close to failure which is indicated by orange color, while for the beam structure elements expressed which are indicated by the green color shown in Figure 3.

**Figure 3.** Modeling and analysis results

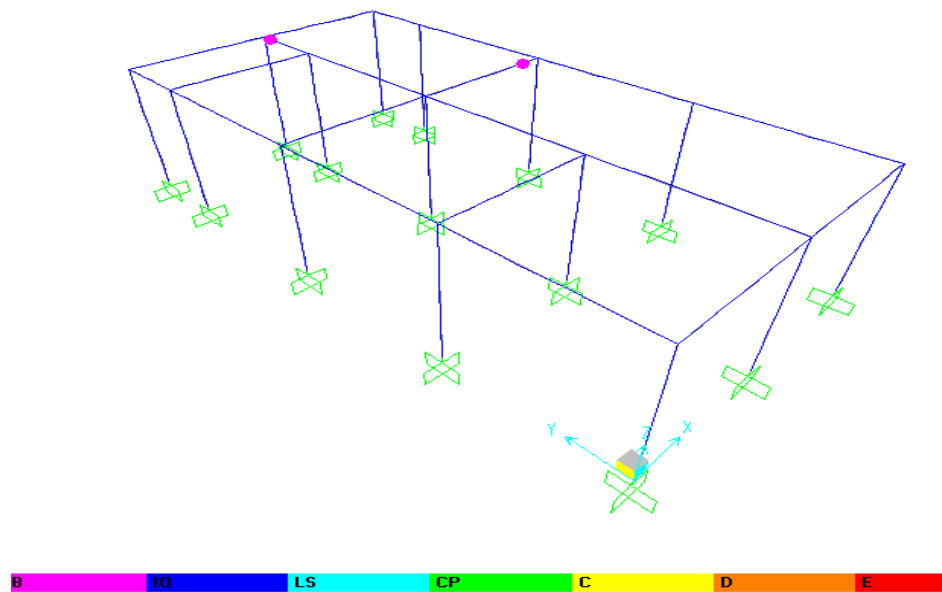
Furthermore, modeling with FEMA 356 was obtained from the pushover method found in SAP2000 V10 to produce plastic joints in the beam and column structure elements. In steps 1 up to step 6 with colorful nodes shown in Figure 4 and Figure 5. Description of pushover color nodes in plastic joints is based on Table 2 which is divided into 7 levels described in Table 3. According Figure 5, the front part of the house is not able to withstand the shear and shattering forces, while the back part is still function. Therefore some reinforcement is necessary to keep the evacuation route through the house front.

**Figure 4.** Plastic joints that occurs in step 1

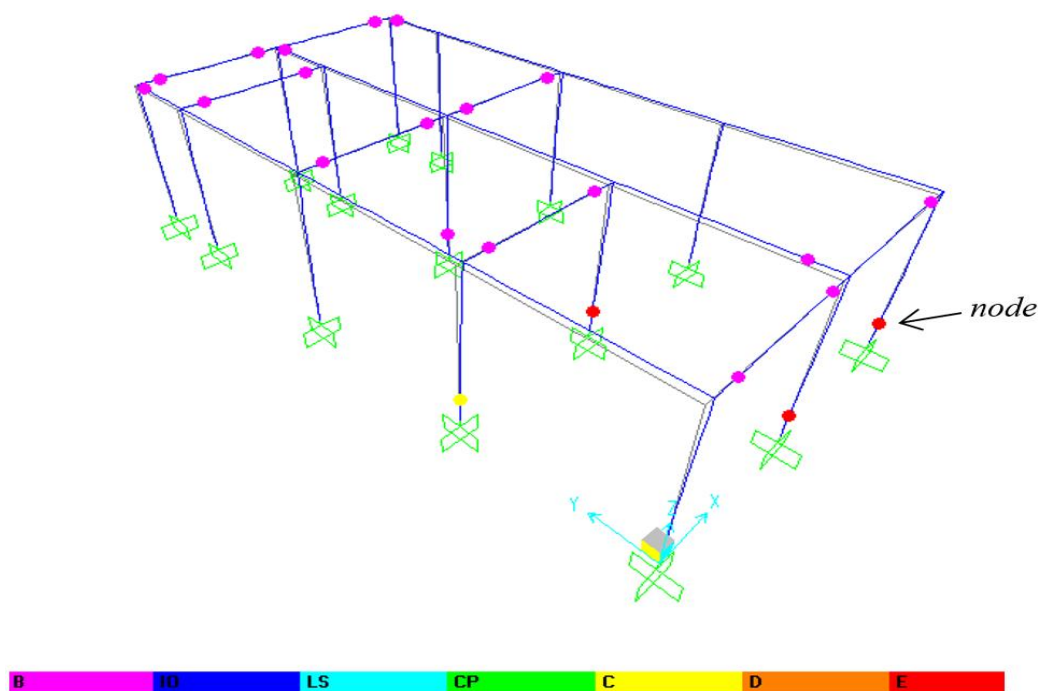
**Figure 5.** Plastic joints that occurs in step 6

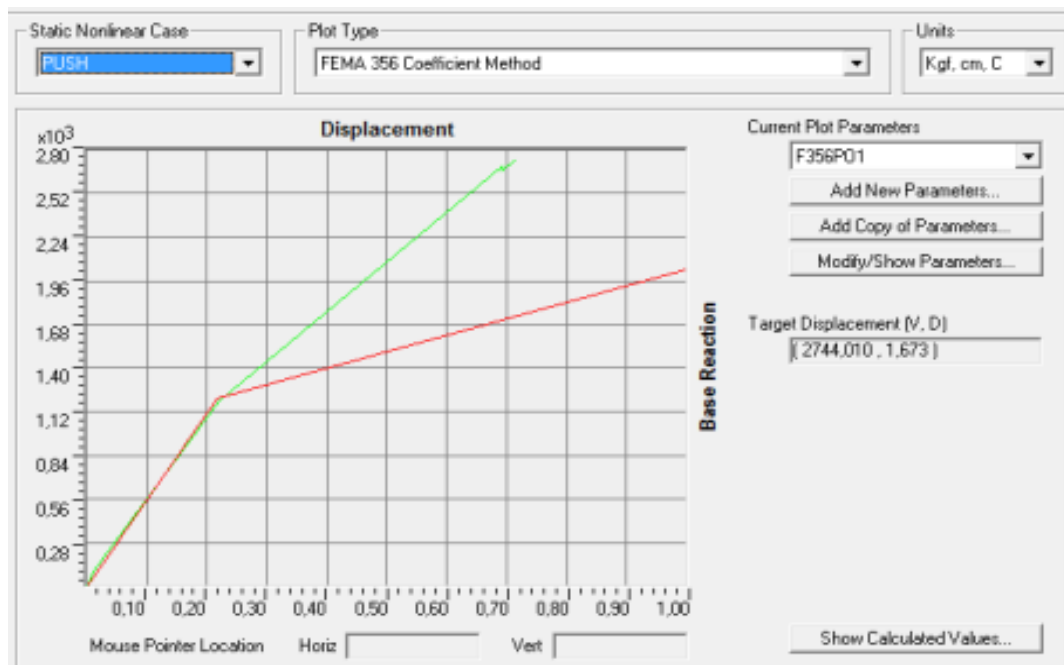
Pushover also produces curves referring to FEMA 356 shown in Figure 6 and generates the values required for the displacement target ( $\delta T$ ). The values obtained from the FEMA 356 curve are  $C_0 = 1.0$ ;  $C_1 = 1.378$ ;  $C_2 = 1.0$ ;  $C_3 = 1.0$ ;  $S_a = 1.011$ ; and  $T_e = 0.221$ .

**Figure 6.** Pushover curve which refers to FEMA 356

Furthermore, the values are calculated using the equation (1) so that the result of the displacement target value is 0.02 m categorized under table 1 at the Life Safety (LS) performance level. This means

that if there is a movement of land, the structure of the house is stable and has adequate service capacity and damage non-structural part is still controlled.
